# Syndesmotic malreduction may be caused by a lag screw used in distal fibula fracture fixation

The aim of this study was to present a case of syndesmotic malreduction after syndesmotic fixation and to identify a previously undocumented cause of malreduction in the literature.

**Keywords:** Ankle fracture, fixation, lag screw, malreduction, syndesmosis.

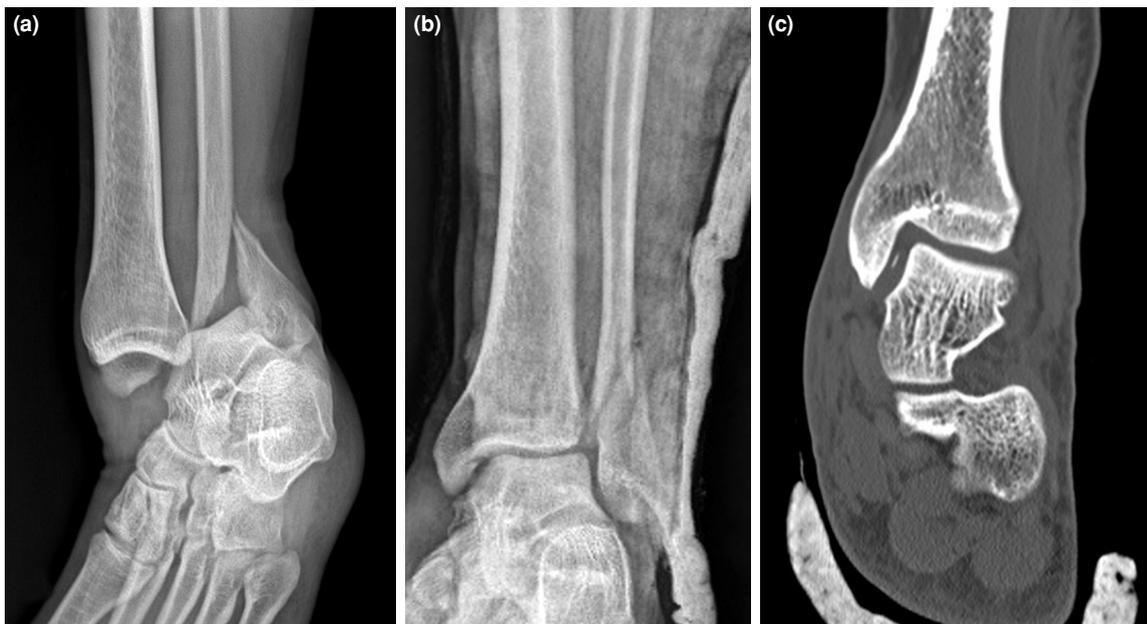
**Figure 1.** Preoperative ankle AP radiographs and CT scan. **(a)** Anteroposterior ankle radiograph of a Weber type C malleolar fracture and ankle dislocation. **(b)** Anteroposterior ankle radiograph of a Weber type C lateral malleolar fracture and syndesmotom separation. **(c)** Computed tomography scan demonstrating deep deltoid ligament avulsion, and insertion into the medial joint space.

A 36-year-old male patient presented to our clinic in August 2020 with an ankle fracture-dislocation after pronation-external rotation injury. Anteroposterior (AP) radiograph of the ankle revealed a Weber type C fracture of the distal fibula and ankle dislocation (Figure 1a). He had no additional injuries or chronic diseases. He was a teacher. The ankle fracture-dislocation was initially closed reduced in the emergency department under sedation, a short leg splint was applied, and ankle AP radiographs were taken after reduction. Post-reduction AP radiography revealed Weber type C lateral malleolar fracture and syndesmotic separation (Figure 1b). Post-reduction computed tomography (CT) revealed an opening in the medial clear space due to a deep deltoid ligament avulsion (Figure 1c).

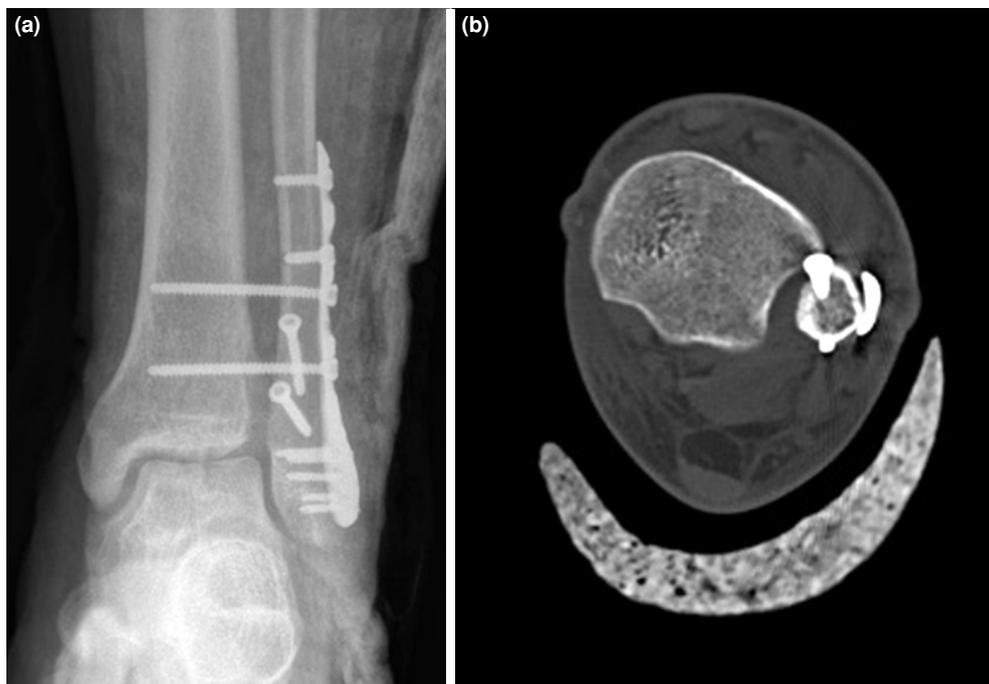
**Figure 2.** Postoperative ankle AP radiograph and CT scan. **(a)** Postoperative AP radiograph after syndesmosis screw fixation. **(b)** Computed tomography axial section scan showing compression of the lag screw in the incisura fibularis.

However, syndesmotic malreduction was suspected when the tibia-fibular overlapping was 2 mm on postoperative radiographs taken the next day (Figure 2a). A CT scan of the operated ankle was obtained. As demonstrated in CT axial sections, the lag screw head entered the incisura fibularis and prevented syndesmotic reduction (Figure 2b).

The patient was reoperated as the screw had blocked the anatomical reduction of the syndesmosis. General anesthesia and a thigh tourniquet were applied to the patient. The syndesmosis screws were then removed, and the lag screw entering the incisura fibularis was removed. A 3.5 mm 3-cortex full-threaded cortical screw was placed parallel to

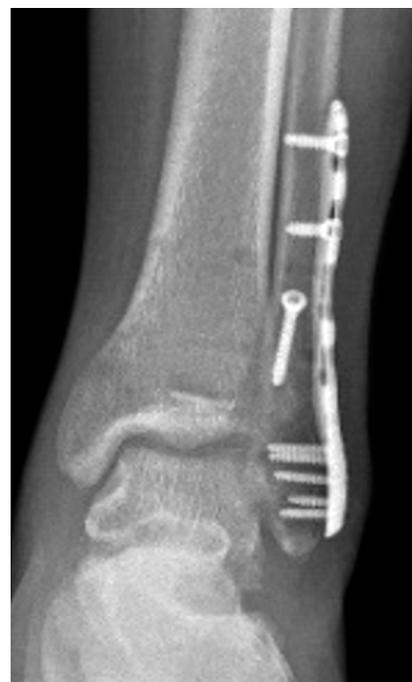
**Figure 4.** Anteroposterior radiograph of the ankle following removal of the syndesmosis screw.

been achieved under fluoroscopy control (Figure 3a). After the operation, the reduction was demonstrated with axial CT sections (Figure 3b). The patient's weight bearing was limited for six weeks, after which the syndesmosis screw was removed (Figure 4). The patient returned to normal activities four months following the operation. At the one-year follow-up assessment in August 2021, there was no restriction in ankle range of motion. The patient was informed that data from the case would be submitted for publication and gave their consent.
